MMM SURVEYS

REPORT NO 19/20

CONDITION SURVEY ON GLASTRON GS279

Date of Survey: 25 Nov 2020

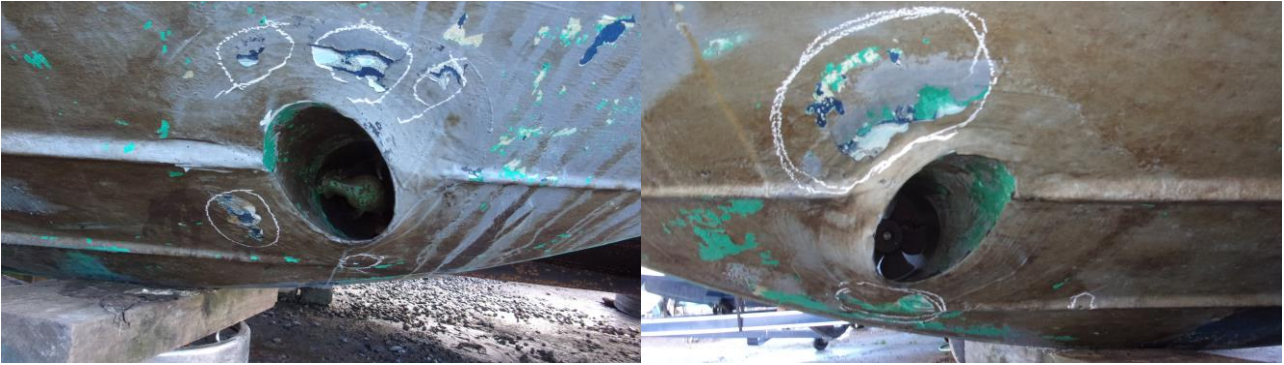
The retro-fitted bow thruster tube had been faired into the hull using gelcoat. Some areas were brittle and breaking away; this is possibly the result of curing at too high a temperature (too much catalyst). It is recommended that the area be ground back then re-faired using gelcoat/flocoat mixed according to the manufacturer's instructions. See areas circled in the photos below:

Location	Defect	Recommendations
Bow	Bow thruster tube fairing compound breaking away	Grind back and apply gelcoat/flocoat according to the manufacturer's instructions.
Strakes	Various exposed GRP	Grind back and apply gelcoat/flocoat according to the manufacturer's instructions.
Topsides & quarters	Various exposed GRP	Grind back and apply gelcoat/flocoat according to the manufacturer's instructions.
Transom	Holes for lamp brackets and wires	Plug holes. Fit gland or otherwise seal wire for lamp.

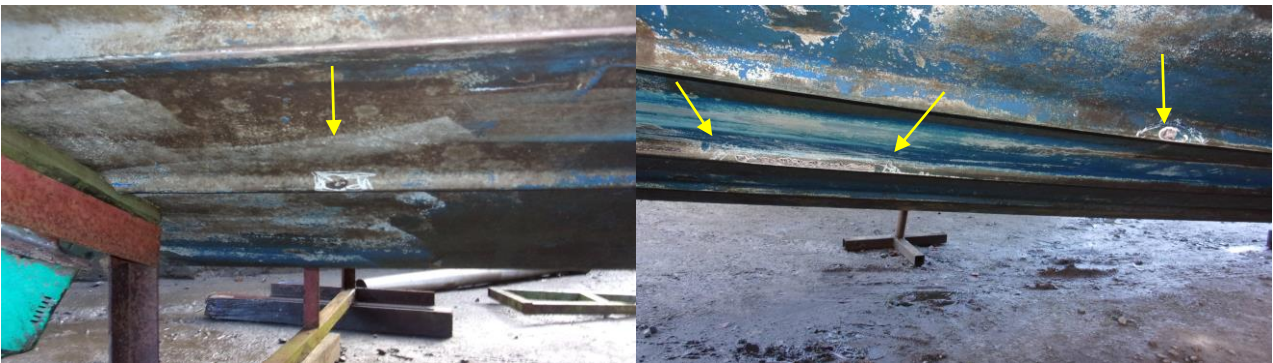
There were various area of exposed GRP on the lifting strakes, possibly due to chipping of the gelcoat when launching/recovering on the trailer. The areas are as follows:

- Stbd inner strake, aft, 1cm² (shown below)
- Stbd outer strake, mid, 1cm²
- Port inner strake, fwd 1cm²
- Port middle strake, fwd/mid, 1cm²
- Port middle strake, mid, 1cm x 24cm (shown below)
- Port outer strake, mid, 1cm² (shown below)

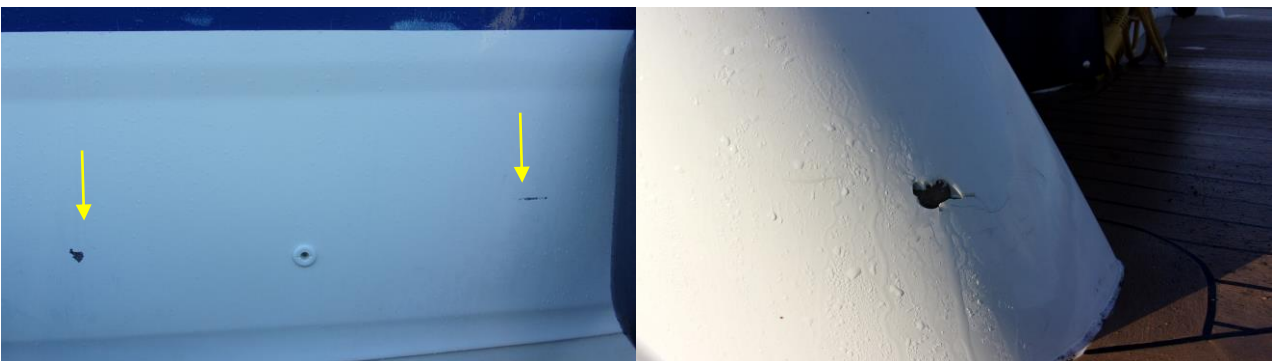
The topsides were finished in blue and white gelcoat which was in good general condition and had some shine to it. There were various scrapes in the gelcoat; some had been filled but not faired smooth. These are purely cosmetic issues. There were various areas of exposed GRP which need filling and fairing:

- Port bow, white, 1cm²
- Stbd, mid, white, 2 scrapes (shown below)
- Port quarter, white, 1cm² (shown below)
- Stbd quarter, blue, 1cm²
- Port quarter, white, beside cleat, 1cm²

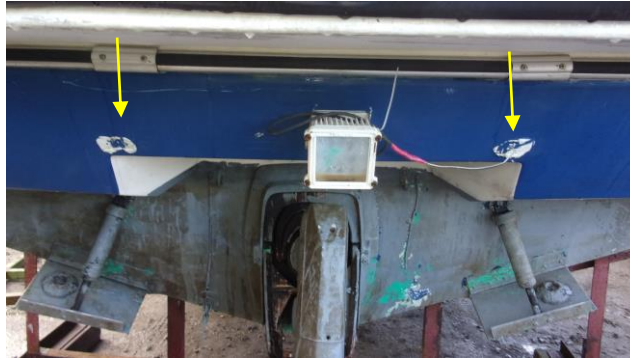
Some brackets (for lamp fittings) have been removed (see photo below) from the transom leaving holes which should be filled. The wire for the existing lamp exits an un-sealed hole; this needs a gland or other waterproof seal.

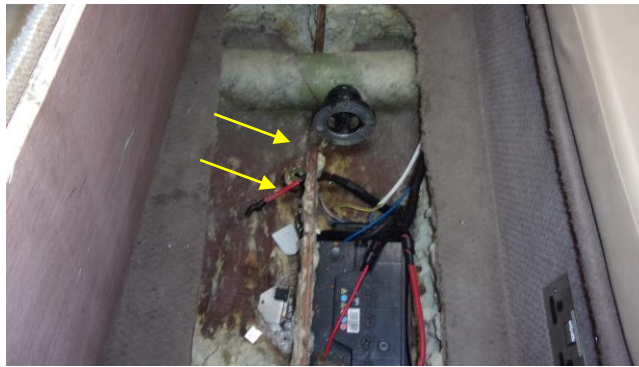
A longitudinal dwarf bulkhead had been cut to facilitate fitting of a bow thruster; this should not impact upon hull strength. The tube was well glassed in although some fibre ends had not been wetted forward of the tube; it would be worth wetting these out.

Location	Defect	Recommendations
Bow thruster tube	Some un-wetted fibres	Wet out fibres with resin

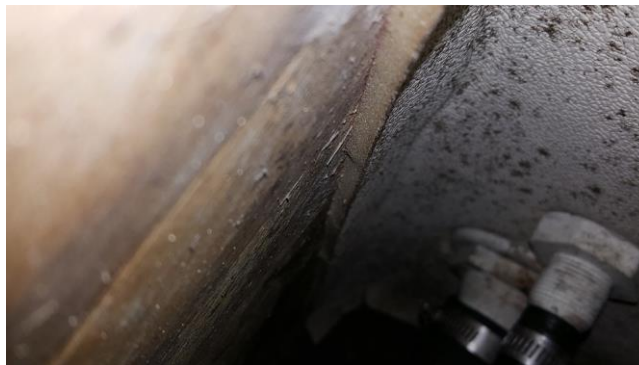
Two suspected cockpit drains are located behind the moulded lining in the heads and discharge at the waterline around midships on the starboard side. These have hoses secured with single stainless steel jubilee clips. They could be photographed, but not reached by hand so their security cannot be guaranteed.

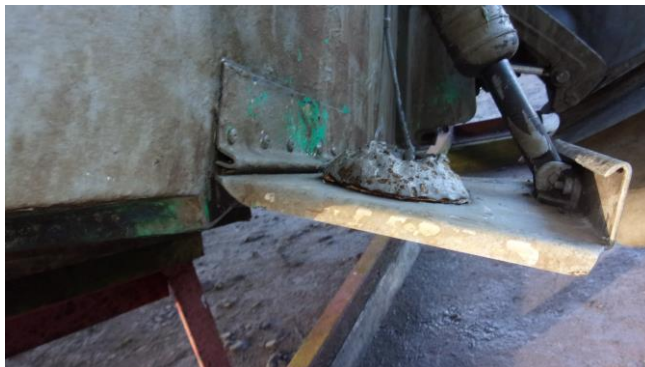
A pair of aluminium trim tabs were fitted to the transom. The port trim tab was slightly bent and would benefit from being straightened.

Location	Defect	Recommendations
Engine compartment	Heads outlet seacock handle corroding	Consider de-rust and paint now, or replace when needed
Transom	Port trim tab bent	Straighten

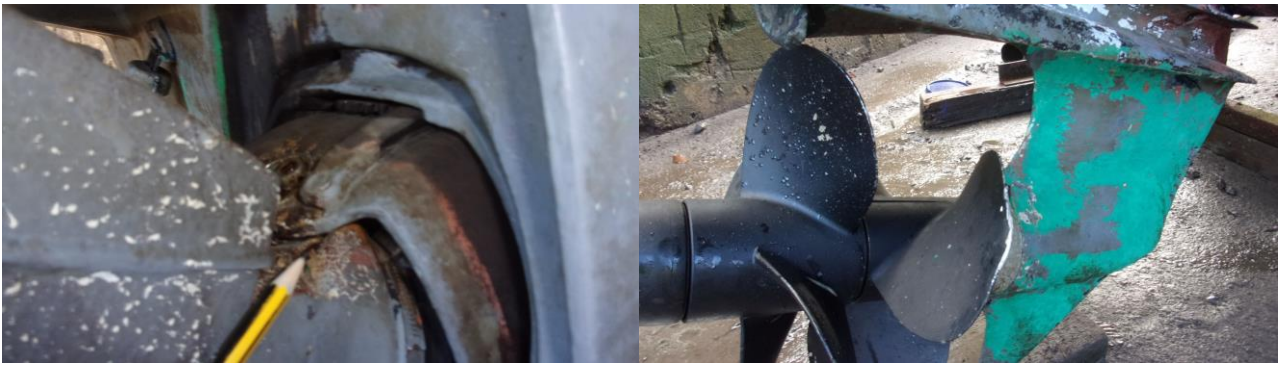
The steering helmet bush and tap were loose (below left photo) generating play in the leg. It may be possible to tighten the tap however, the bush may need to be replaced. The leg was fitted with A4 propellers; the forward propeller had 2 dented blades which would benefit from being straightened.

Location	Defect	Recommendations
Outdrive leg	Steering helmet bush loose	Tighten or replace
Outdrive leg	Forward prop – 2 dented blades	Straighten

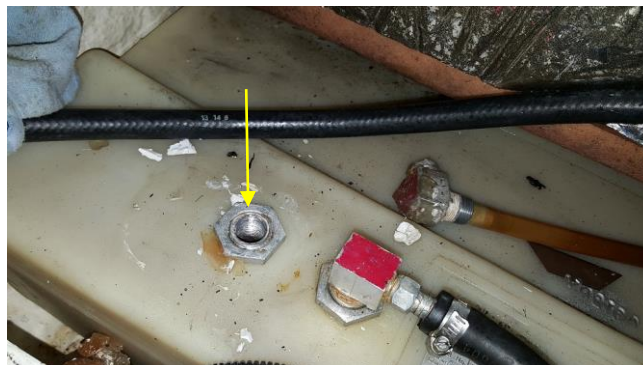
The plastic fuel tank was located under the aft cabin berth; what could be seen was in good condition. A fitting was removed from the port side of the tank; this needs to be replaced to close up the tank. The owner stated he had removed it to allow fitting of the new diesel heater.

Location	Defect	Recommendations
Engine compartment	Fuel fitting removed	Refit

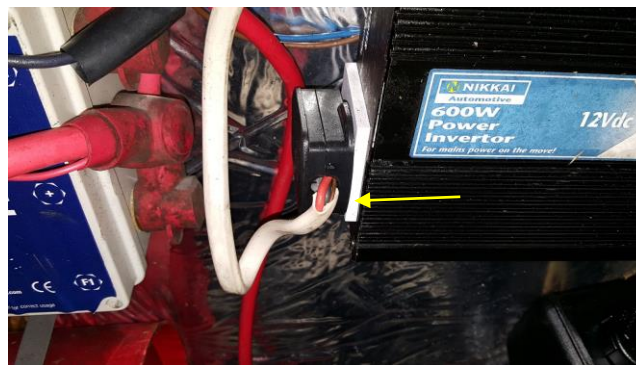
A Charles 15A battery charger was fitted on the forward engine compartment bulkhead. A Nikkai 600W inverter was fitted to port of the charger. The sheathing on the 240V cable had withdrawn exposing the live/neutral/earth wires. The cable should be re-secured into the plug.
