# MMM SURVEYS

REPORT NO 20/20

PRE-PURCHASE SURVEY ON JEANNEAU SUN ODYSSEY 29.2

**Date of Survey:** 09 Dec 2020

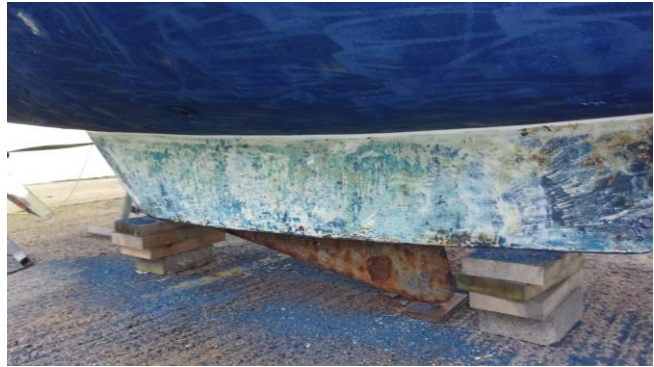
The ferrous lifting keel was serviceable but had considerable surface corrosion which needs to be addressed in the next season or two. This may require removal of the stub keel.

Location	Defect	Recommendations
Lifting keel	Surface corrosion	Remove keel, remove/treat rust, apply protective paint scheme
Stbd rudder	GRP breaking away	Repair GRP

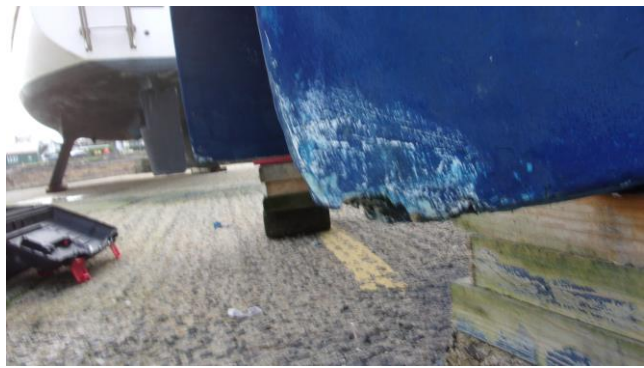
The starboard rudder was damaged at the aft end of the bottom edge. This should be ground back to sound material before applying GRP to restore strength and prevent water ingress.

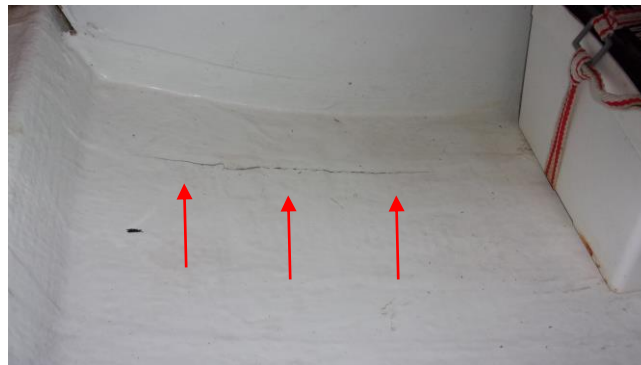
Tabbing between the hull and the dwarf bulkhead at the aft cabin door had become detached. While not structural at the time of writing, this should be repaired soon by grinding back to solid material, applying fibreglass/resin and re-finishing in brushable gelcoat.

Location	Defect	Recommendations
Aft cabin	Hull to bulkhead tabbing breaking away	Grind back to solid material, re-glass and apply gelcoat

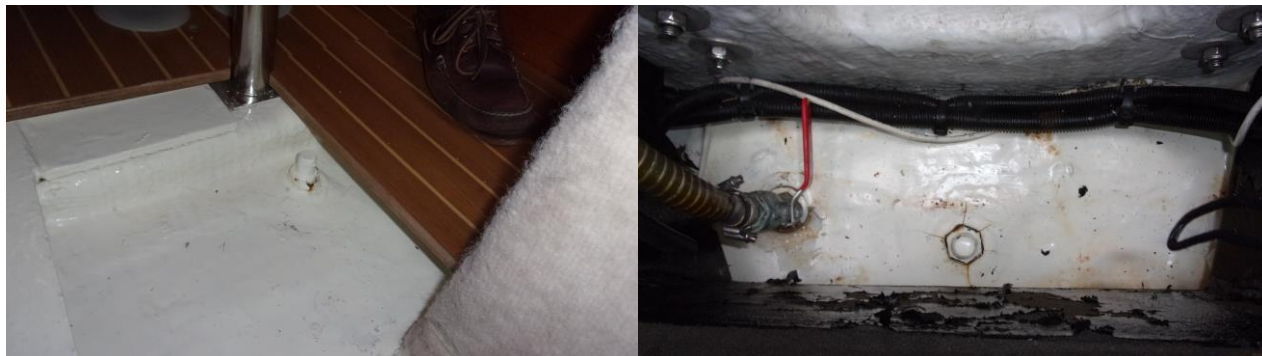
The stub keel was secured to the hull via six stainless steel studs and ferrous steel nuts which were all in a serviceable condition. The owner had removed the resin overcoat on four of the nuts and removed/replaced one nut for inspection. Rust stains and spider cracks were present at the remaining two encapsulated nuts. It is recommended that the resin be removed from these, the corrosion addressed and all six nuts re-covered in resin.

Location	Defect	Recommendations
Saloon	Two keel nuts yet to be serviced	Remove resin, remove corrosion from all 6 nuts, recover in resin

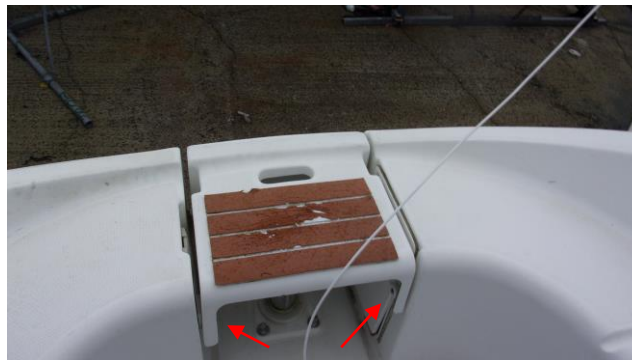
The infill seat, aft in the cockpit, had some surface stress cracking in the gelcoat and the synthetic teak on top was damaged/scratched. The white plastic locating studs (see red arrows below) were loose and should be tightened.

Location	Defect	Recommendations
Cockpit	Infill seat locating studs loose	Tighten

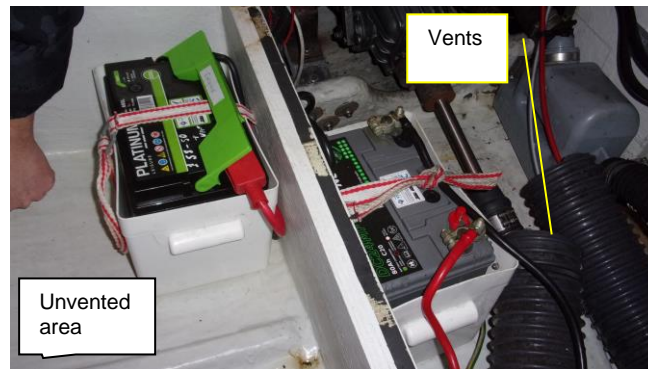
Two batteries were present under the aft cabin berth. The battery labelled 'engine' (green handle – Type 685L 75AH) was a venting battery but was not in a vented area. Either vent the battery into the engine compartment or replace it with a sealed battery. Note there were two vent holes on the battery, so either fit elbows and tubing to each end or plug one end.

Location	Defect	Recommendations
Aft cabin	Green battery not correctly vented	Vent into engine compartment or replace with a sealed battery
Aft cabin	Grey battery missing protection for positive terminal	Fit terminal protector or battery box lid
